Investigation of Indoor Air Quality

Kingston Secondary School
145 Kirkpatrick Street, Kingston, Ontario

**Limestone District School
Board**

December 16, 2024

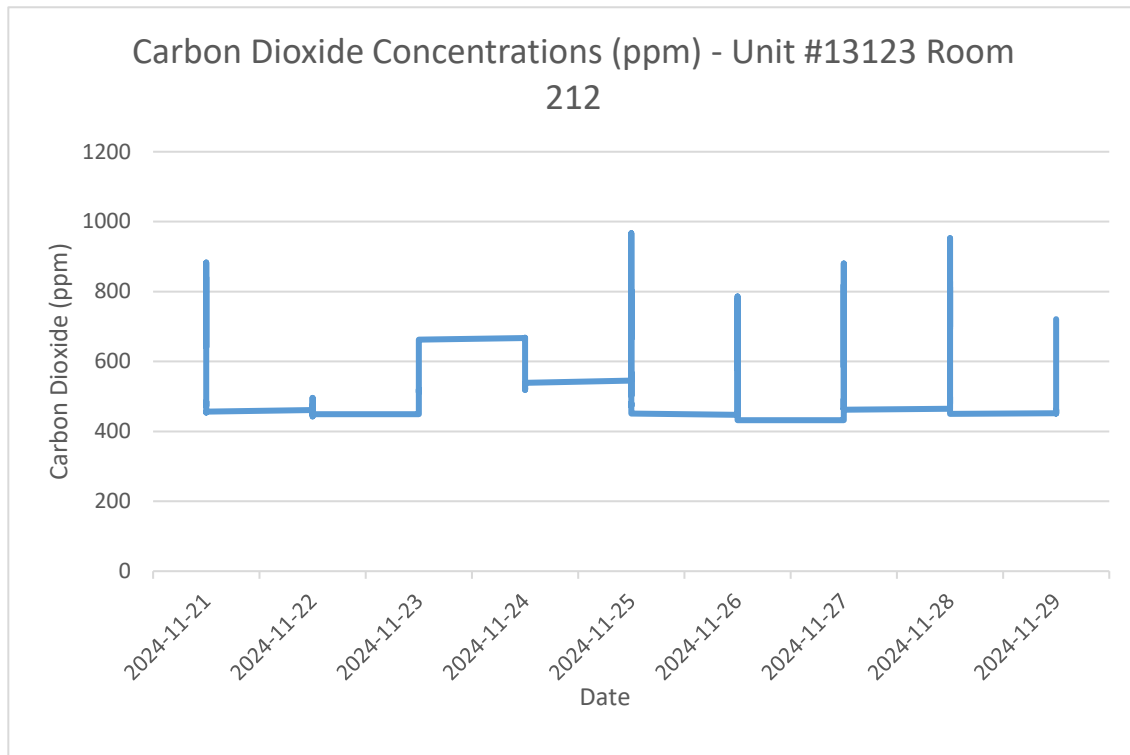
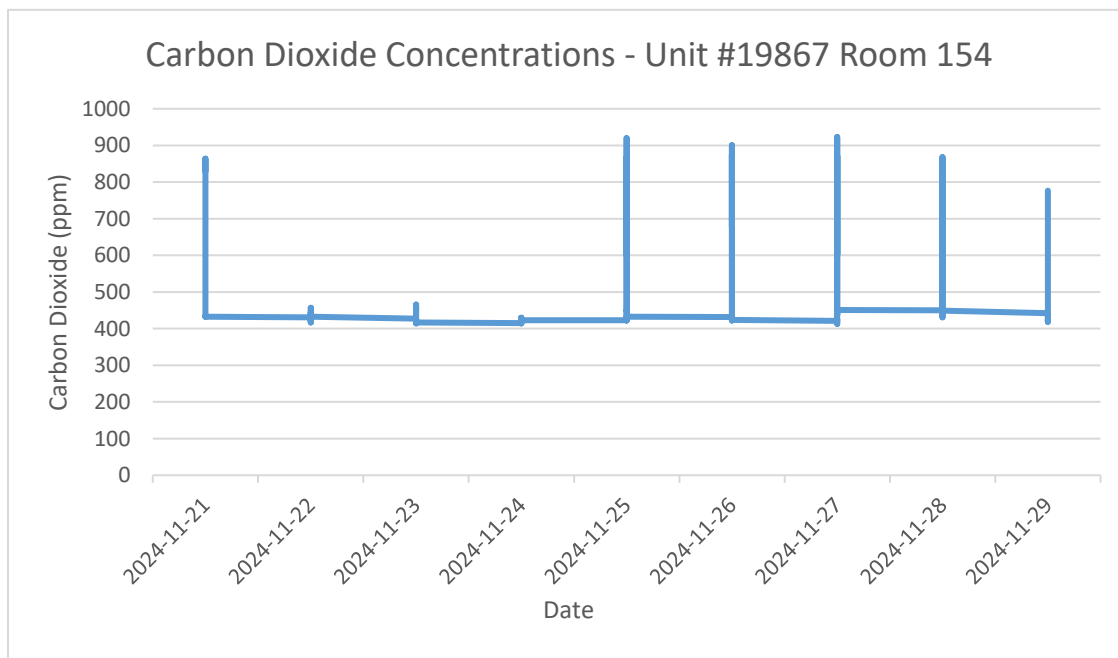
Results of Data-Logging Indoor Air Quality Measurements

Pinchin deployed three monitors to data log the carbon dioxide in the building. The units were deployed from November 21 to November 29, 2024, with a log interval of one hour.

Parameter	Concentration		Suggested Limit	Within Suggested Limit?
	Minimum	Maximum		
CO ₂ Monitor #19867, Room 154	432 ppm	967 ppm	Outdoor Air ppm + 700 ppm	Yes

CO ₂ Monitor #13123, Room 212	413 ppm	923 ppm	Outdoor Air ppm + 700 ppm	Yes
CO ₂ Monitor #12492, Room 302*	568 ppm	700ppm	Outdoor Air ppm + 700 ppm	Yes
